TRANSPORTATION SAFETY

REFLEXIONS

Issue 3 - July 2002

P I P E L I N E

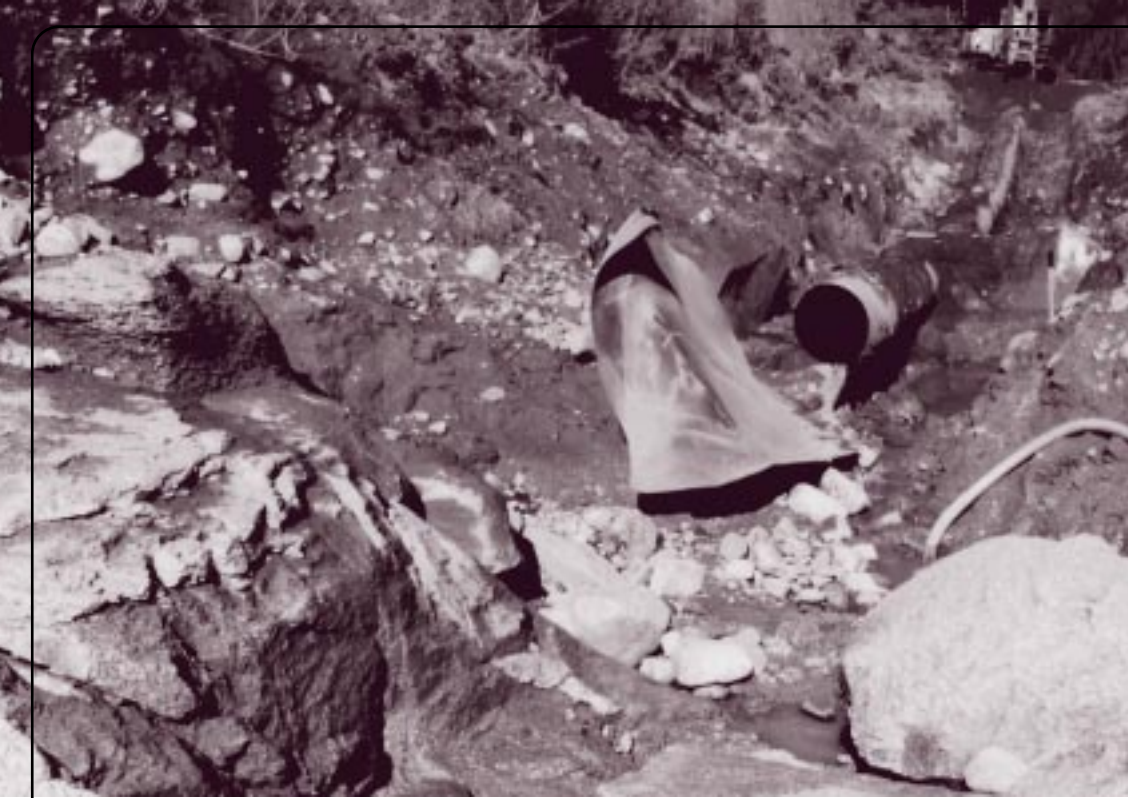
**Downstream end
of rupture.**

On 07 August 2000, a rupture occurred on the Westcoast Energy Inc. (Westcoast) mainline at a localized area of higher hardness, a hard spot, on the exterior surface of the pipe. The hard spot probably resulted from inadvertent quenching during the manufacturing process. The rupture occurred approximately 9 km south of the Coquihalla Highway toll booth (toll booth) and almost midway between Westcoast's Compressor Stations 8A and 8B. — Report No. P00H0037

- completion of in-line inspections for hard spots of the sections of the mainline;
- aerial patrol of the mainline and the mainline loop sections using infrared imaging technology to determine leaks;

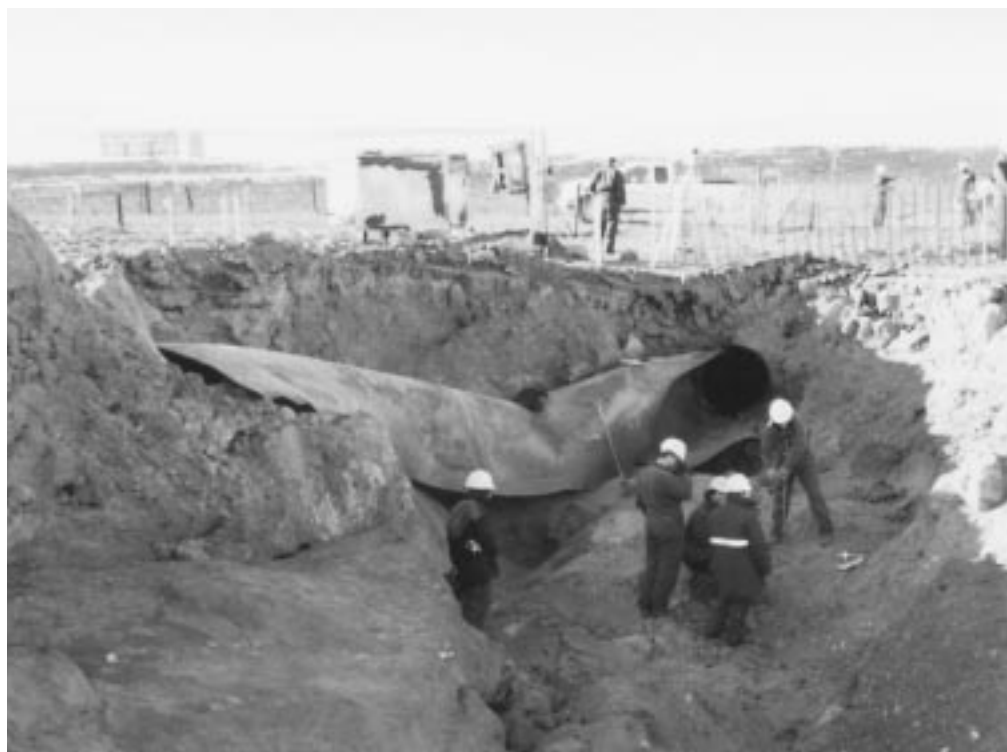
Subsequent to the December 1996 rupture, on 02 December 1997, the TCPL pipeline system experienced another rupture at an area of external corrosion, this time on Line 100-3 near Cabri, Saskatchewan. The pipeline ruptured as a result of localized wall thinning due to external corrosion which had occurred where the pipe coating had either been damaged or become disbonded. Between 68 and 72 per cent of the original wall thickness had been lost due to corrosion.

The Board found that the corrosion occurred during periods when the cathodic protection on the pipeline was insufficient according to the criteria that TCPL was trying to achieve, which would occur during periods of down-time of the cathodic protection system that arise during construction, depolarization or system improvements. Seasonal variations in soil conditions would have contributed to the rate of corrosion and the amount of current required for adequate cathodic protection.

Ruptured pipe on Line 100-3 near Cabri, Saskatchewan.

Following the Cabri occurrence, TCPL revisited its accelerated in-line inspection program. As a result, TCPL further accelerated the in-line inspection program for sections west of MLV 41. In addition, in the spring of 1998, TCPL began implementing a program to improve its corrosion control practices by adopting the best

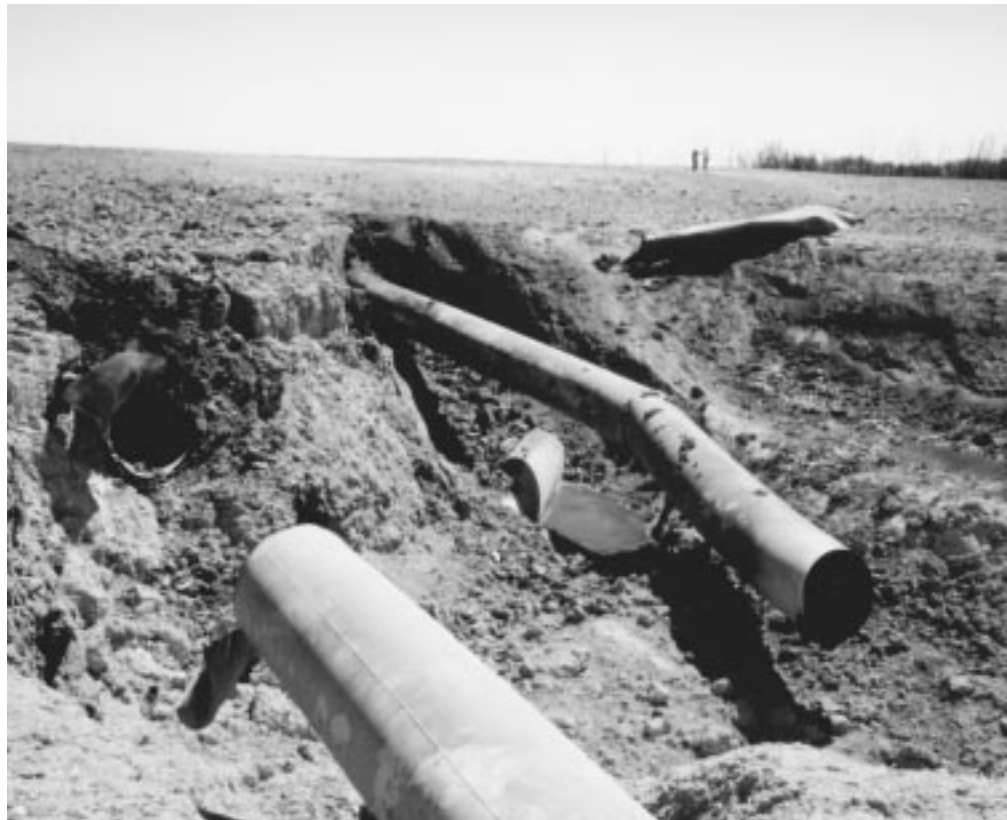
A rupture and fire occurred on TCPL's Line 100-4 on 29 July 1995, at a TransCanada PipeLines Limited (TCPL) compressor station about 3 km southeast of Rapid City. The rupture occurred as a result of a pre-existing stress corrosion crack (SCC) in a piece of pipe downstream of the compressor station. This piece of pipe had been fabricated in the field and coated with polyethylene tape.

The resulting explosion and fire destroyed much of the communications system at the compressor station and made it difficult to shut off the flow of gas in Line 100-4. As a result, TCPL's Line 100-3, adjacent to Line 100-4, sustained fire damage that weakened it, and it too ruptured and caught fire. TCPL's Line 100-5 which passed under Lines 100-3 and 100-4 sustained minor fire damage to the coating of the pipe.
— Report No. P95H0036

Ruptured Lines 100-3 and 100-4.

Following the rupture near Rapid City, TCPL expanded its SCC management program, consisting of hydrostatic re-testing, soils modeling to assist in determining potential SCC

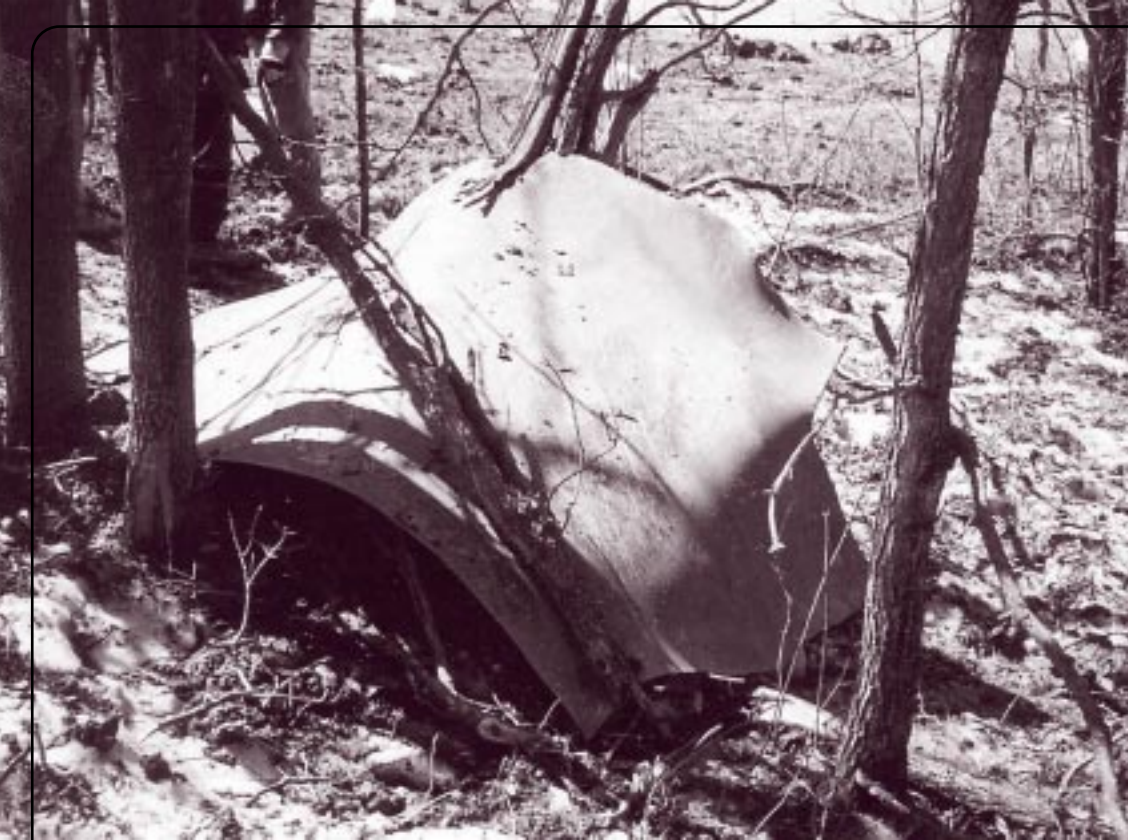
Fragment landing site with La Salle River in the background.

A rupture, followed by an explosion and fire, occurred on the TransCanada PipeLines Limited (TPCL) Line 100-2 crossing of the La Salle River, 10 km southwest of Winnipeg, near the town of St. Norbert, Manitoba, on 15 April 1996. The pipeline ruptured due to high external stresses on the surface of the pipeline resulting from the movement of the slope in which the pipe was buried. The rupture initiated at a major pre-existing defect in the toe of the circumferential weld. — Report No. P96H0012

The rupture initiated at a major pre-existing defect in the toe of the circumferential weld. It is possible that the initial crack was there from the time of the original construction in 1962. The main loading force leading to the failure came from pipe bending caused by the movement of the slope in which the pipe was buried.

- The SCADA telemetry connection has been modified to re-establish communications with a compressor station in the event of a loss of primary telemetry signal.
- The emergency procedure manual has been rewritten to permit deviation from the established "total shutdown" procedures.
- Procedures have been amended to allow for faster notification of its management teams.
- A long-term program has been established to ensure the success of the site stabilization and monitoring instituted for the La Salle River crossing.
- A system-wide geotechnical program will examine the pipeline rights-of-way for evidence of slope movement, and will assemble a database of soil types, pipe

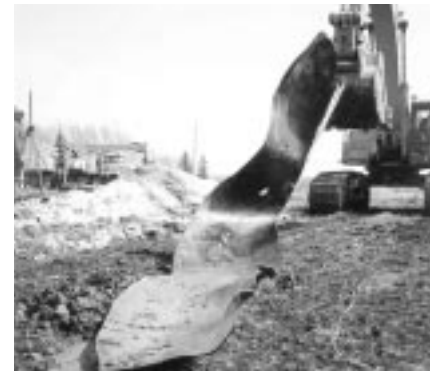
Second fragment retrieved from river bottom.

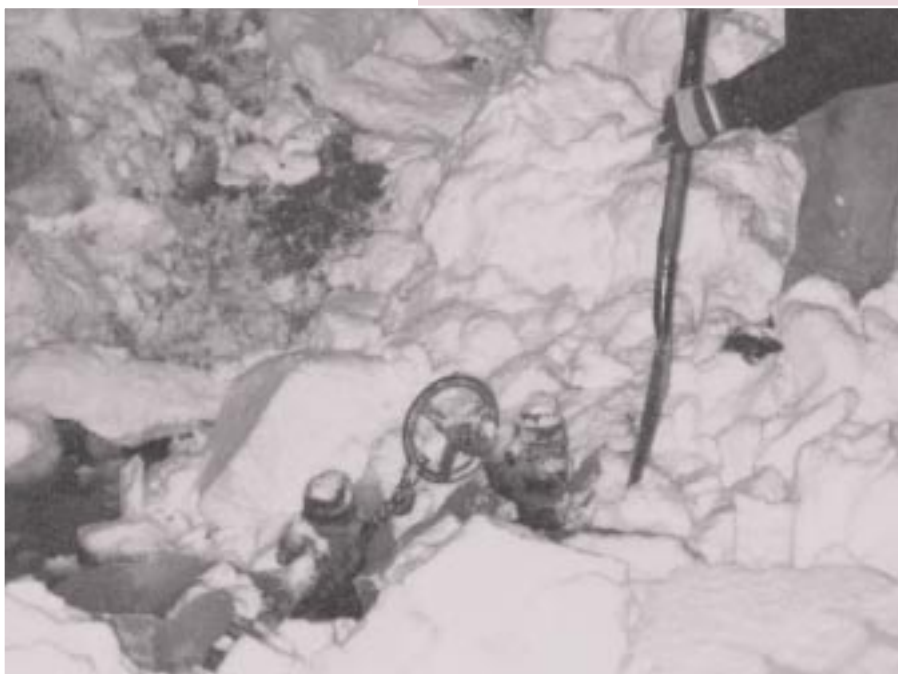
Tapping connection.

During that period, the excavation filled with water, ice and snow, and the threaded connections could be viewed as becoming a buried structure at the bottom of the opening. Although periodic inspections of the open ditch were completed by TNPI, TNPI personnel did not ensure that there were no situations developing in or around the exposed pipeline that could threaten the safety of the system. TNPI personnel were not issued with specific instructions regarding the company's concerns with respect to the exposed pipe in the open ditch. During the eight-month period that the pipeline was exposed, TNPI personnel had performed 32 vehicle inspections together with weekly overflights of the occurrence area. However, the identification of the potential hazard of ice accretion and snow cover in the bottom of the ditch was not addressed.

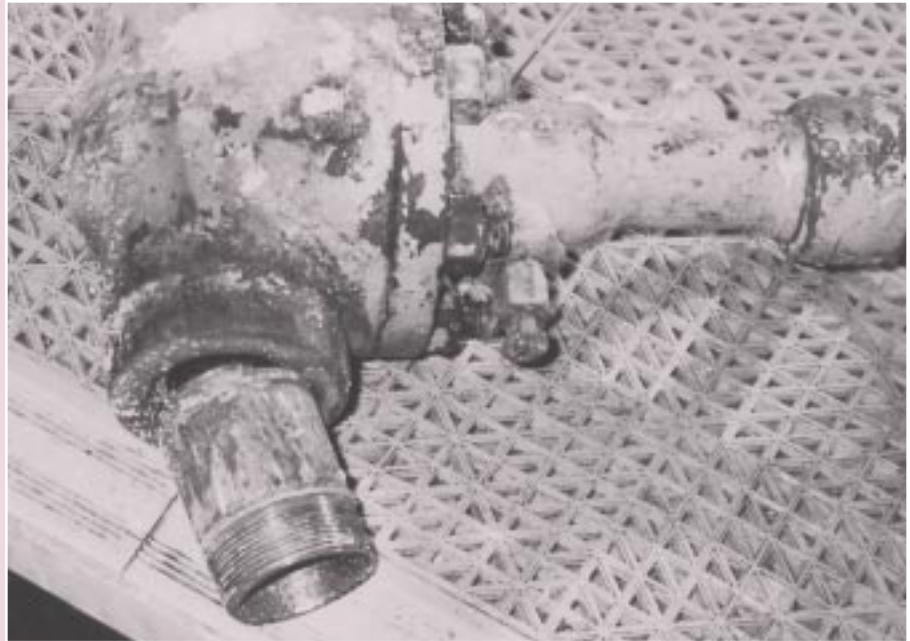
Failed nipple.

The substantial ice load pressing down on the two tapping connections led to the nipple failure. The nipple was made of plain carbon steel of relatively low strength with a large ferrite-pearlite grain microstructure, both conducive to a brittle-type failure under overload in cold weather conditions. Contributing to the occurrence was the fact that inspection personnel were not given specific instructions on what to monitor and the action to be taken.
